3.3.4 Interior

3.4 Clothing Store Building 58

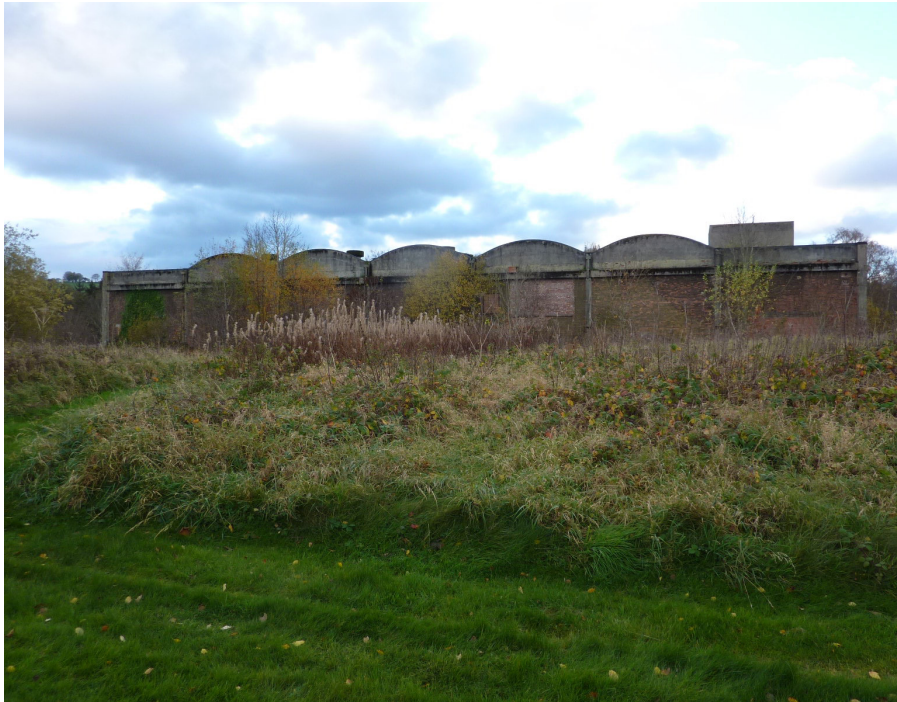
Fig. 045 Building 50 Former Pyro Building P5

Along the west elevation, at low level, there is a drainage run as seen on the other buildings. This is constructed in reinforced concrete and steps up from some 300mm from floor level and is approximately 1 m wide. It is generally solid in terms of its appearance however, in a number of places it has been displaced by the tree growth along this elevation. There are a series of trees of varying sizes again in close proximity to the building, whilst these are relatively small along this elevation at the moment, in only a few years they will grow to a size which may cause displacement of masonry and consequent deterioration in the building fabric.

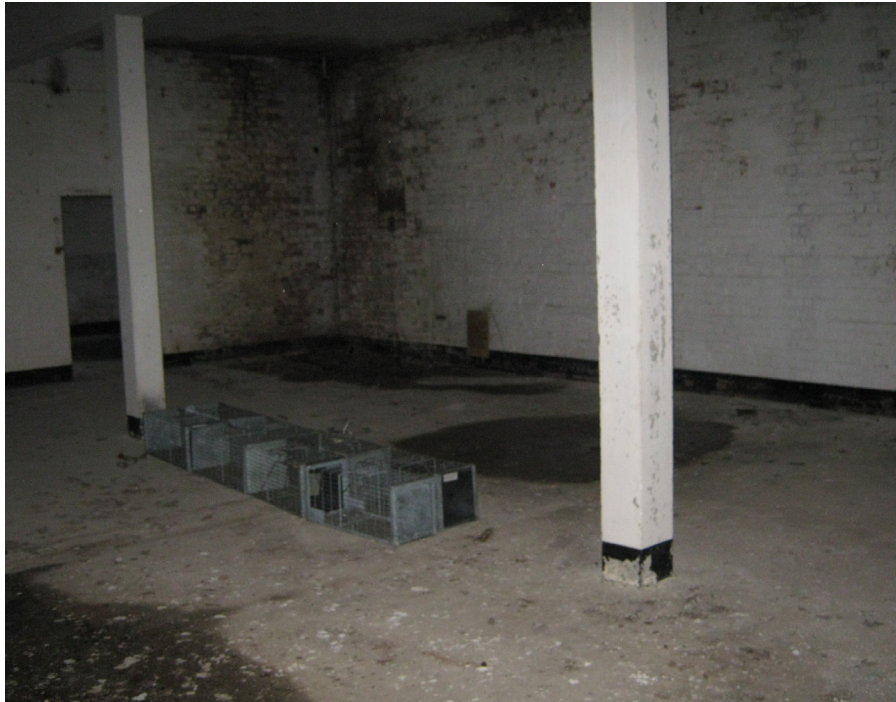
Fig. 050 Building 58 Clothing Store

The roof is a cast in-situ reinforced concrete slab covered in what appears to be a bituminous roofing felt overlaid with a hot applied liquid. It was not possible to inspect the roof covering from above however, there is extensive organic growth, evidence of cracking, and deterioration all around the perimeter of the building. Sections to the downstand on the west elevation are missing exposing the concrete slab. Similarly to the north-west and south-east corners the roof covering is almost completely missing from the edge of the concrete roof slab. To the east elevation is a small outrigger constructed in stretcher bond with a reinforced concrete slab roof, the flashing above this roof is roofing felt and largely missing allowing ingress at the junction. The roof is covered in organic growth and there are missing sections to the north eastern corner. There are no rainwater goods to the outrigger.

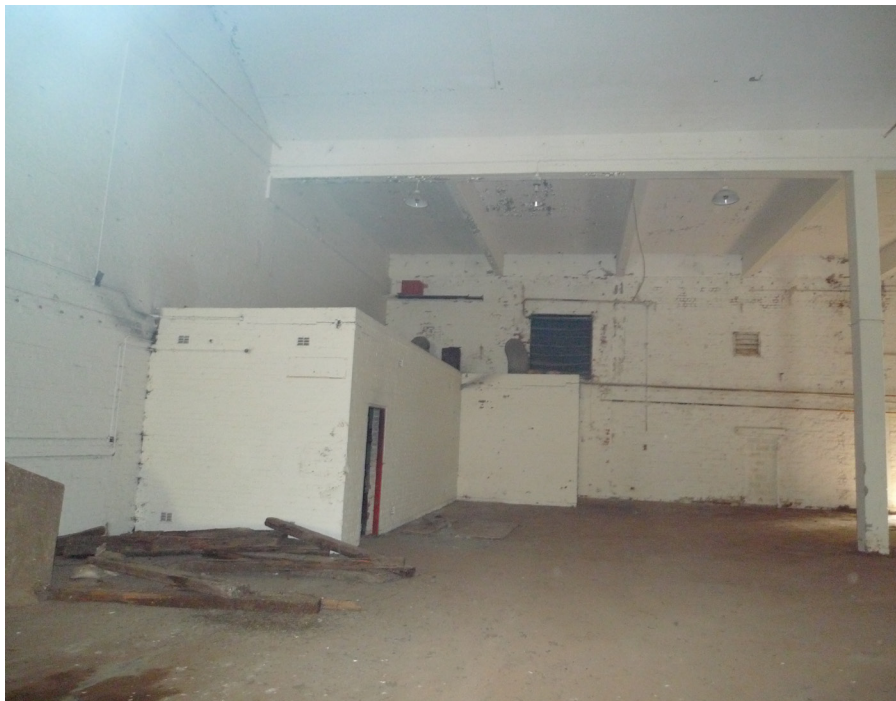
Fig. 058 Building 59 Pyro Building P4

To the northern most bay (indicated Bay 1 on plan), there is evidence that the continuing water ingress is starting to cause deterioration in the reinforcement, with iron staining and cracking caused by corrosion of the reinforcing bars within the concrete.

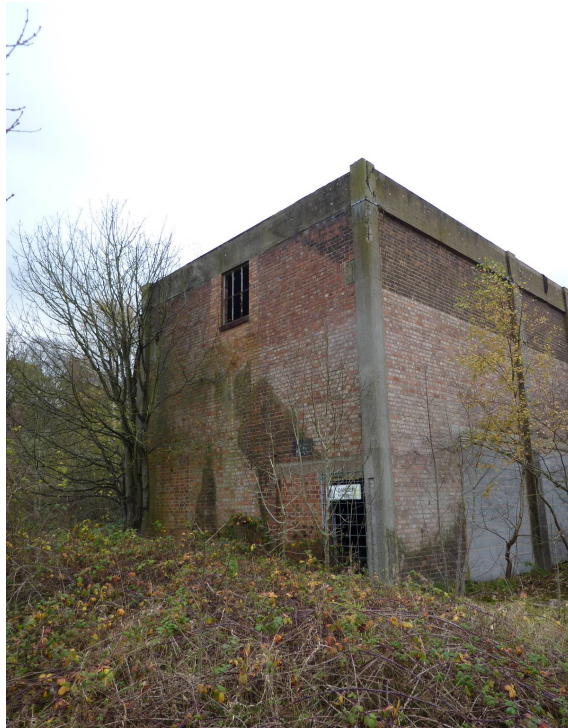
Fig. 062 Building 65 The Runcol Building

This slab is in poor condition with tree growth at the upper level and sections of spalling concrete some of which are falling on to the ground adjacent to the building, this needs quite urgent attention to reduce the risk of falling masonry. Above this is a further storey of brickwork with an iron door still in-situ and atop this, is a reinforced concrete roof slab. When viewed from ground level the brickwork would appear to be in reasonable condition. The covering to the reinforced concrete roof slab is largely missing. The ground floor is also constructed in brickwork and there is a reinforced concrete staircase projecting to the west consisting of 4 risers. This is all in reasonable condition. There is a doorway leading into the building from the staircase which has been in-filled with modern block-work.
