# VALLEY SITE, RHYDYMWYN

# CONDITION REPORT

## Condition Report

Purcell Miller Tritton was commissioned by the Department for Environment Food and Rural Affairs (DEFRA), to undertake a condition survey and security survey on and for the former MS Valley Site, Rhydymwyn, Flintshire, North Wales. Survey work was undertaken during November and December 2010.

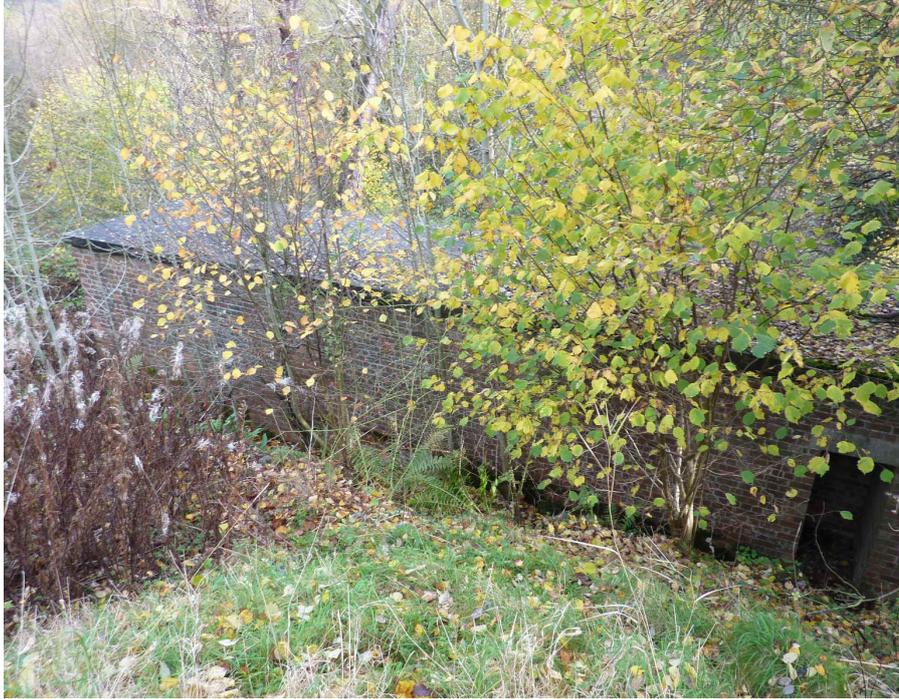
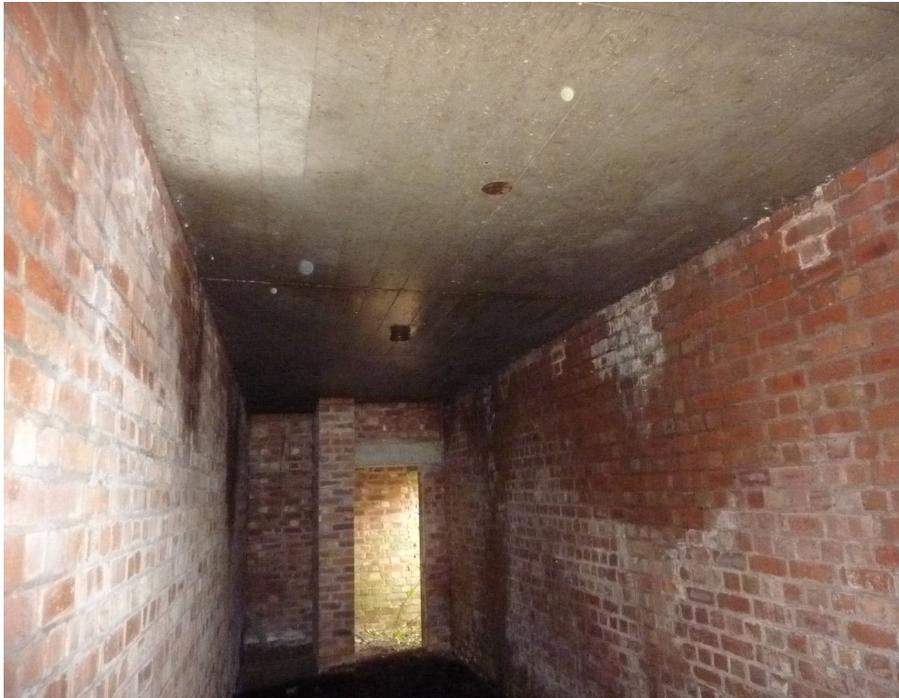
Fig. 003 Building 13 ARP Shelter, West Bank

They are rectangular in plan, with entrances set at opposing ends; Building 13 has the doors at the south-west and north-eastern corners. Internally there were originally two curtained-off toilets at either end, segregated from the entrance lobbies by the internal blast walls (opposite the entrance doors). The entrances would originally have had angled gas curtains, with timber doors internally. The slab to shelter 13 is in reasonable condition when viewed from above. The shelters do not appear to have had a roof covering (i.e. an asphalt coating). The lack of an asphalt coating results in saturation of the slab and retention of moisture, subsequent corrosion of the reinforcing bars results in cracking. This is evident internally, where the northern portion of the slab is particularly wet. There are horizontal cracks at high level, and especially along the South Elevation.

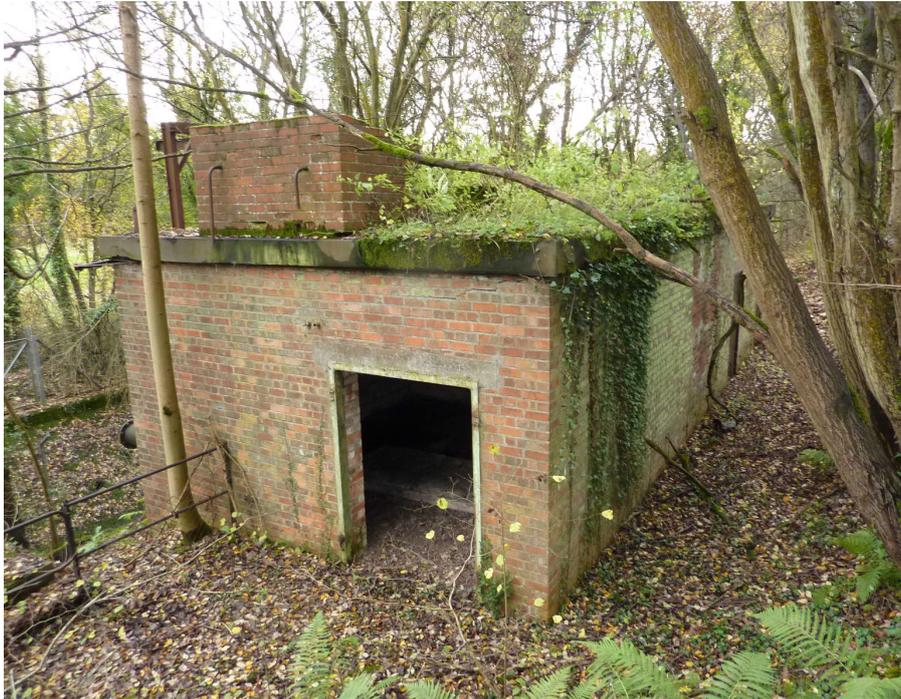
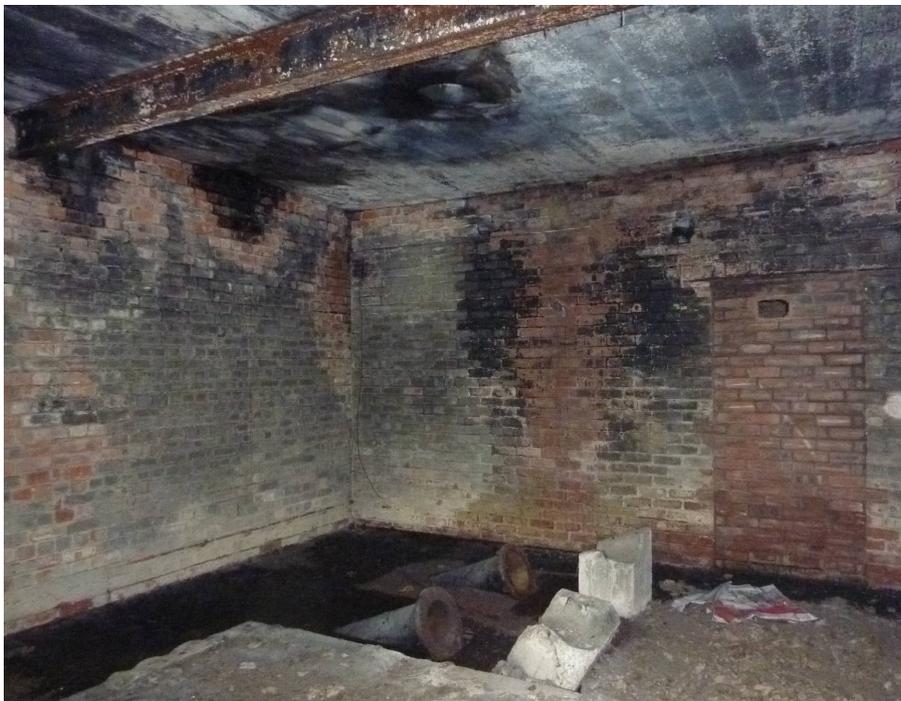
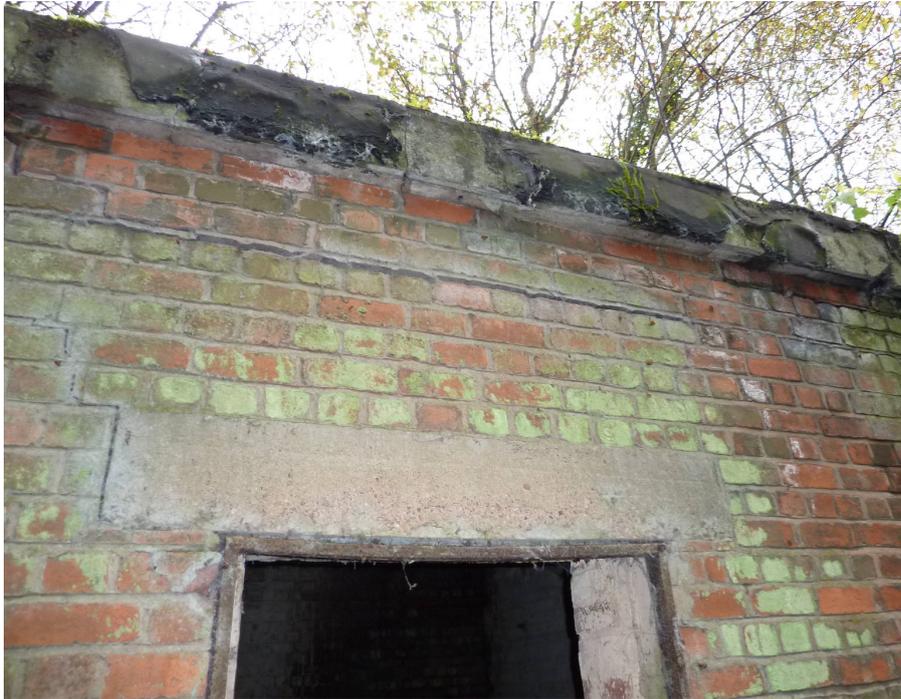
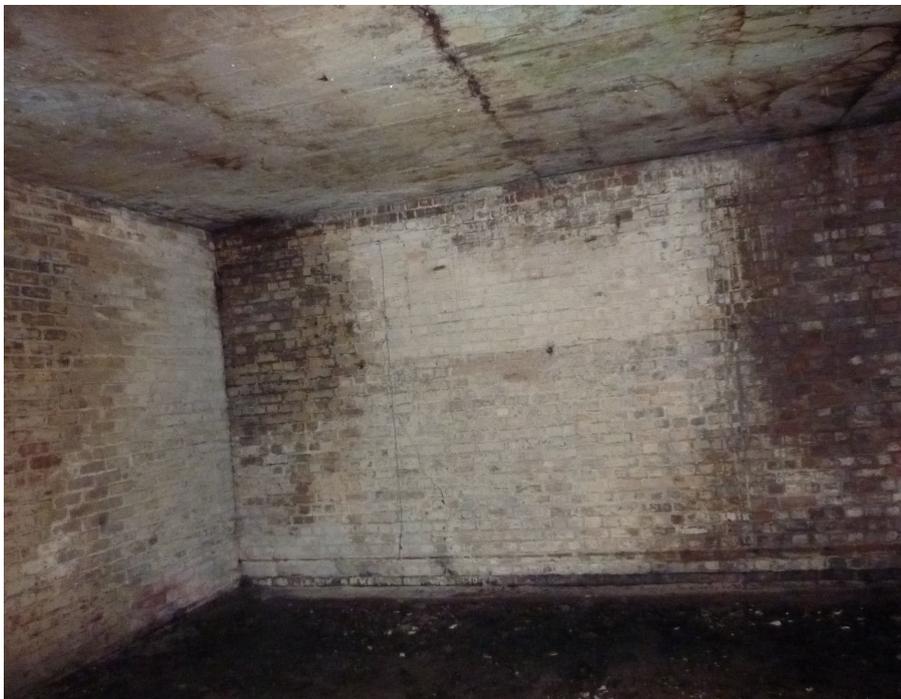
Fig. 005 Building 40/41 Former Booster Pump House and Sub Station SS8

The bituminous covering to the reinforced concrete slab is visible where it turns down the face of the slab. The covering to the West elevation has extensively failed, with sections missing and the covering, where visible, is blistered and failing. There is extensive organic growth atop the roof slab with grass and small plants covering the roof. The extent of water ingress internally suggests that the covering has failed in numerous locations.

The walls are 14" thick brickwork in English bond. The general brickwork and pointing are in good condition, there are however 'jacking' cracks to each corner of the building, varying between two and three courses below the roof slab, these will need to be repaired and monitored.

There are cracks above the lintels over the doors into rooms 2 and 3 (west elevation) extending up towards the roof slab, suggesting some limited settlement to the South end of the building. Given the length and rigidity of the structure (there being no provision for thermal movement) some cracking is inevitable. There are a series of trees growing in very close proximity to the building fabric, particularly to the east, and the north-eastern corners. These should be removed before significant disruption to the building fabric occurs.

The building is divided into three spaces, the pump room (room 1, north), the sub-station and control room (room 2, centre) and the Fire extinguisher/battery room (room 3, south). There is extensive water ingress, particularly in room 2, suggesting extensive failure in the roof coverings.

The two substantial feeder pipes remain in-situ in room 1 and, whilst corroded, they remain in reasonable condition. The void surrounding the pipes is covered with a plate, which is corroded.

The interior of the building is very wet, particularly room 2, suggesting extensive failure of the roof coverings above.

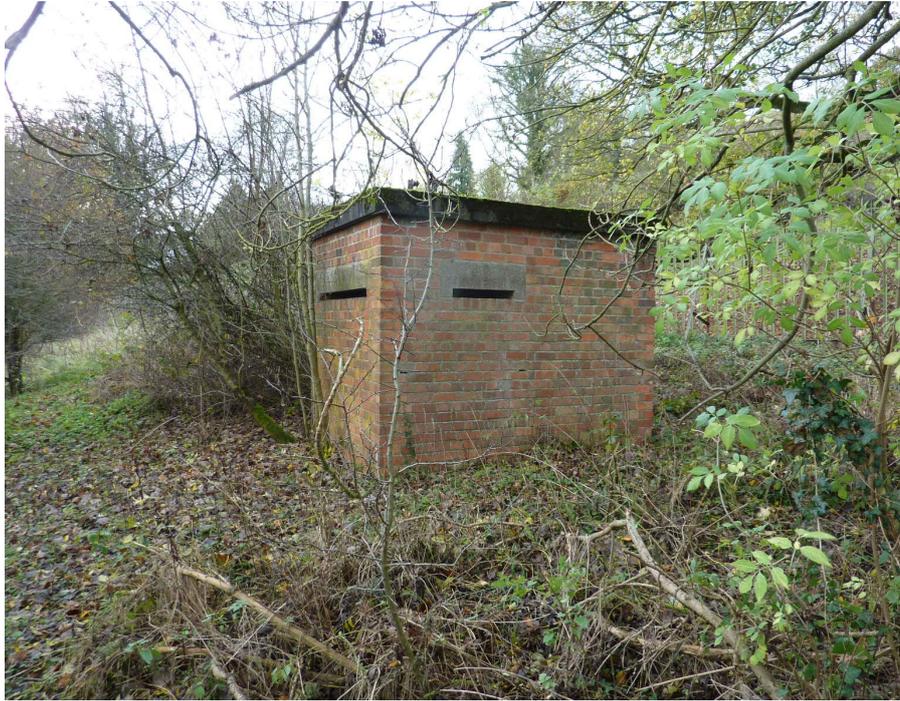
Fig. 009 Building 42 Lookout Post, near Booster Pump House

Building 42 is generally in good condition, there is extensive moss growth on top of the reinforced concrete roof slab, but the building is dry internally. There is no visible evidence that the slab ever had a covering, which seems probable given the intermittent use of the structure historically. There are a couple of spalled bricks, but the brickwork is also in good condition. There are a series of small trees in close proximity to the building (south-eastern corner), which will cause displacement in the medium term, these need to be removed.

Internally the space is dry, but there is accumulated debris as the building is used by animals for shelter. On the walls are remnants of the brackets for the telephone.

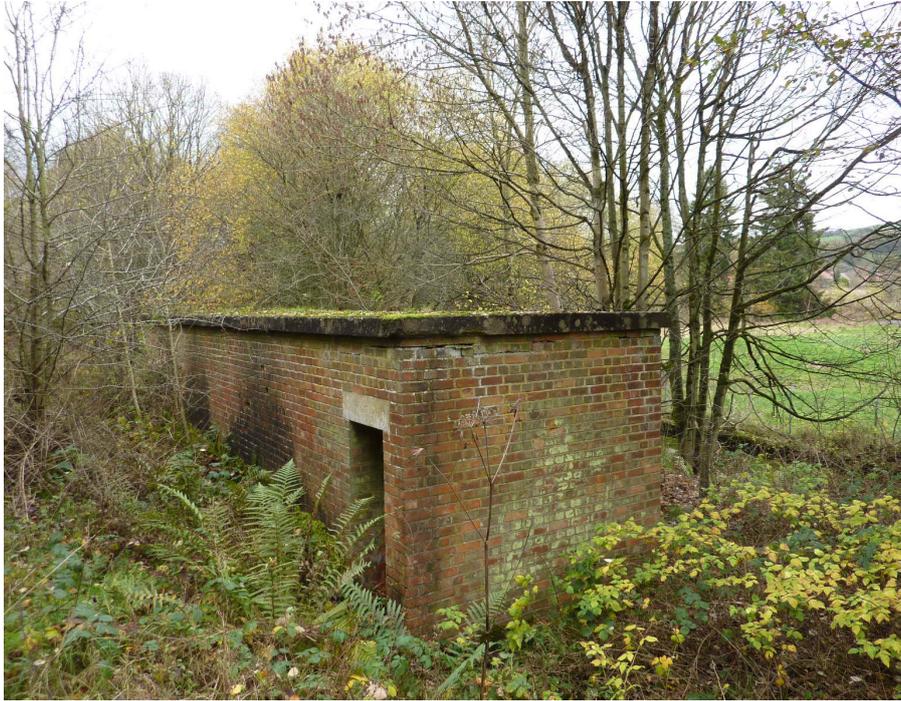
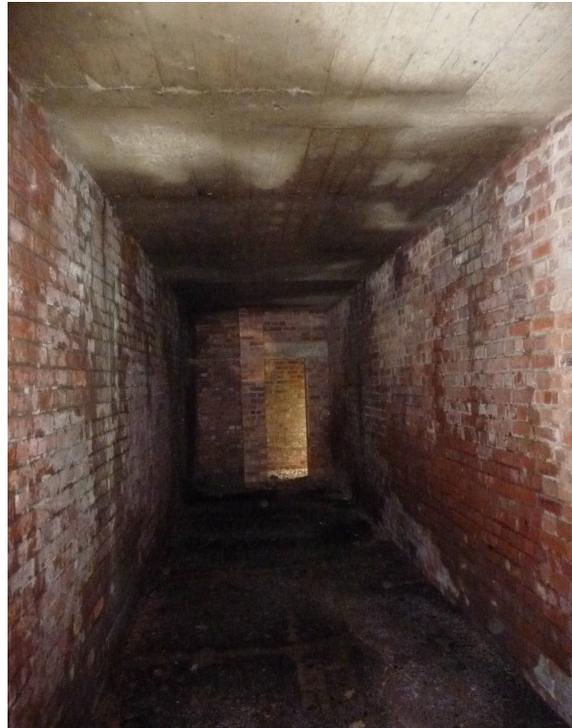
Fig. 010 Building 43 ARP Shelter, West Bank

There are significant spalled sections to the upper arris of the concrete slab, which has begun to expose sections of reinforcement. This, in turn, is starting to corrode. The brickwork is in poor condition, there are numerous badly spalled bricks, plants growing at high-level, including a tree centrally on the east elevation. There are similar cracks at high level as seen elsewhere, those on the South elevation being particularly noticeable.

Internally the underside of the roof slab is very wet. This is most likely due to the amount of organic growth present on the roof retaining moisture, as it is unlikely that the roof had a covering. There is also a substantial crack in the concrete floor slab.

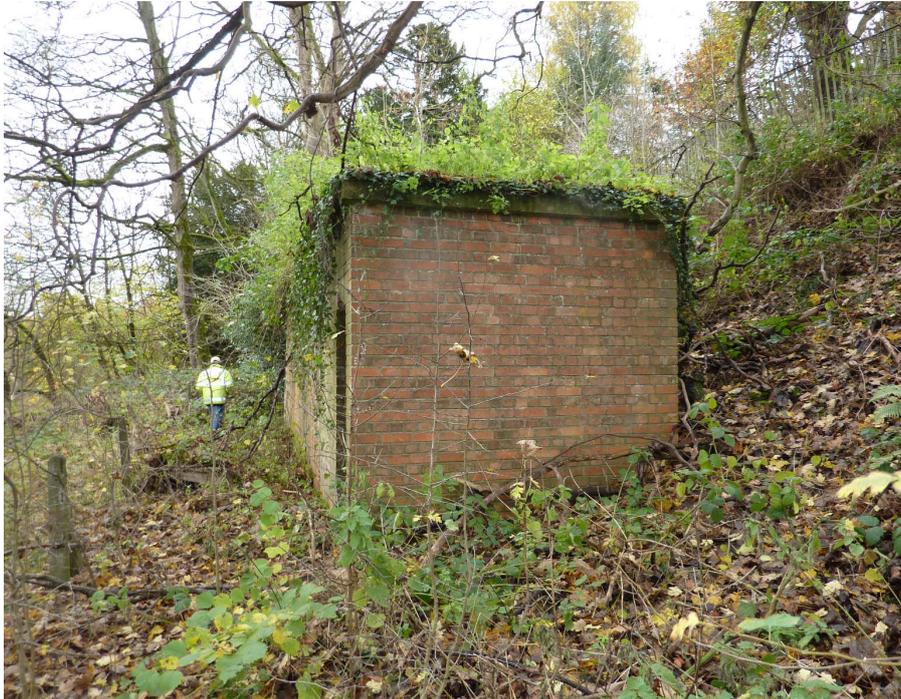
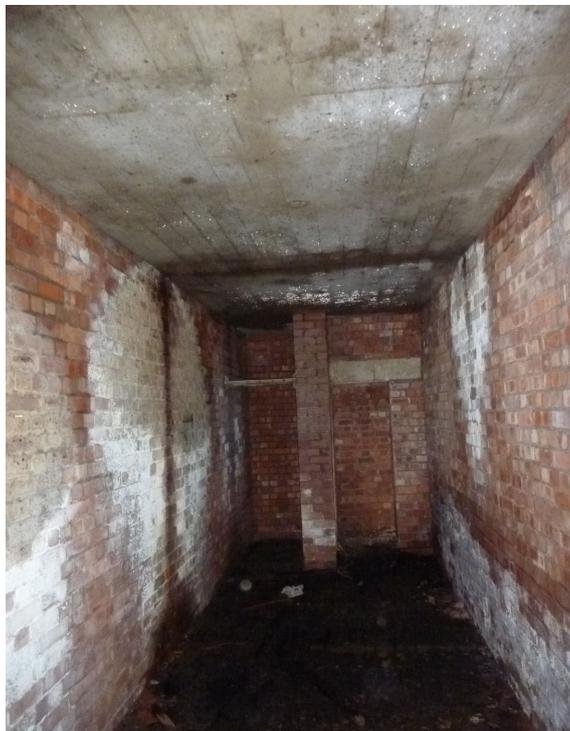
Fig. 012 Building 44 ARP Shelter, West Bank

The roof slab is completely covered in growth, with ivy, grass, plants and small trees. All of which is retaining significant moisture on top of the slab, and the roots of the plants will be accelerating the deterioration of the surface of the roof slab. It seems probable that it is the retention of this moisture which has resulted in corrosion of the reinforcement, and consequent cracking to the slab visible internally. The slab has also has spalled sections to the upper and lower arises.

The brickwork is badly spalled, particularly along the east elevation, although the 'jacking' cracks are less pronounced than on building 43.

Internally the underside of the slab is saturated, with significant cracking (which is now allowing direct ingress of water).

Once again the vegetation could do to be cut back from the immediate vicinity of the building.

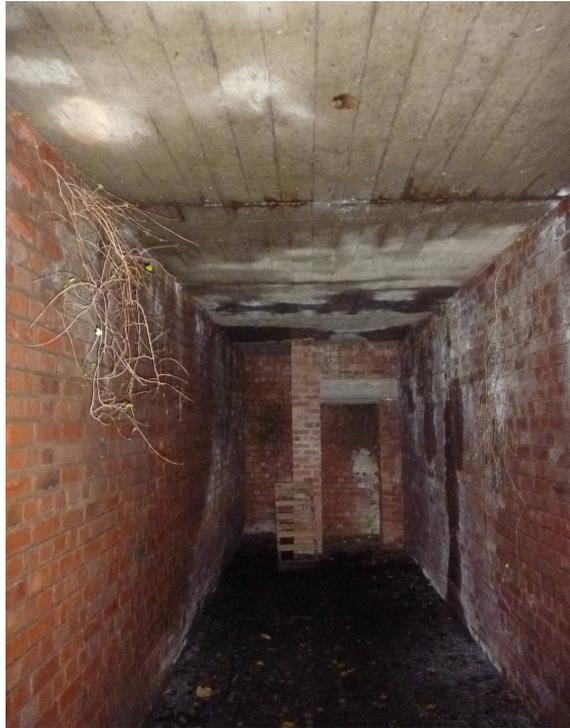
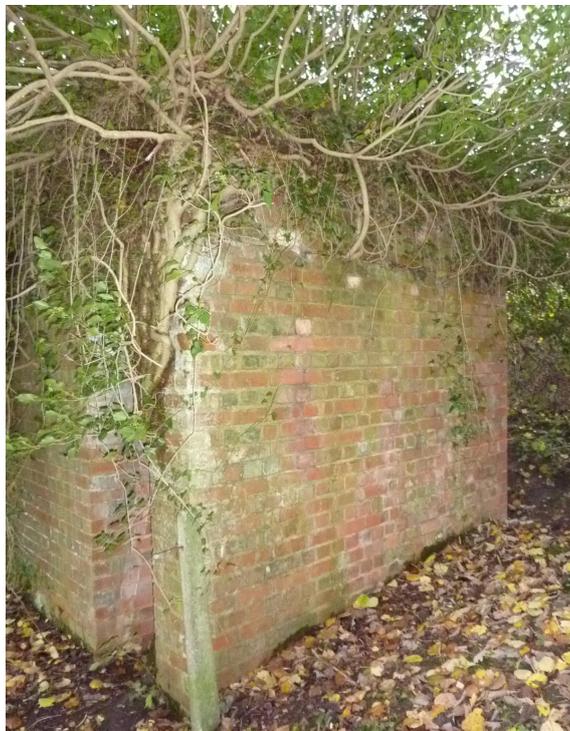
Fig. 014 Building 67 ARP Shelter, West Bank

The roof slab is covered in a very large ivy, the trunk of which is situated in the North-Eastern doorway. Some of the branches of the ivy are starting to grow within the mortar joints, resulting in displacement of the surrounding masonry. Consideration should be given to removing this plant. There are some spalled sections visible to the Northern edge of the slab, however the remainder is obscured from view.

The brickwork is generally in slightly better condition. There are spalled bricks to the east, but the high-level cracking is less pronounced. There is cracking to the south, which is being exacerbated by the presence of the ivy growing within the cracks.

Internally the underside of the roof slab is very wet, and there are cracks running east-west where the reinforcing bars are corroding. There is a crack across the floor slab also. The adjoining tree growth is contributing to this disturbance.

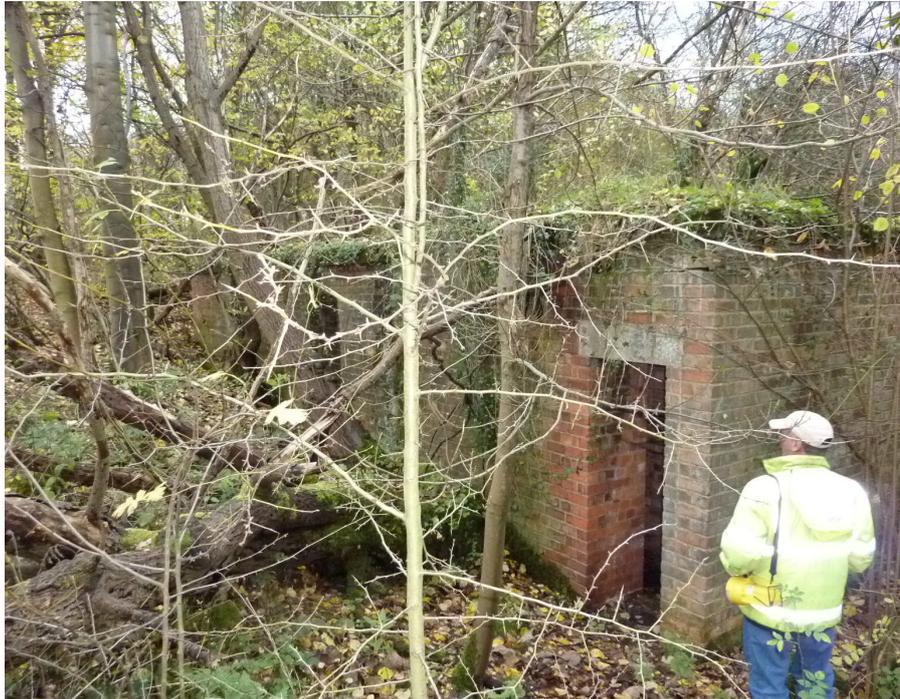
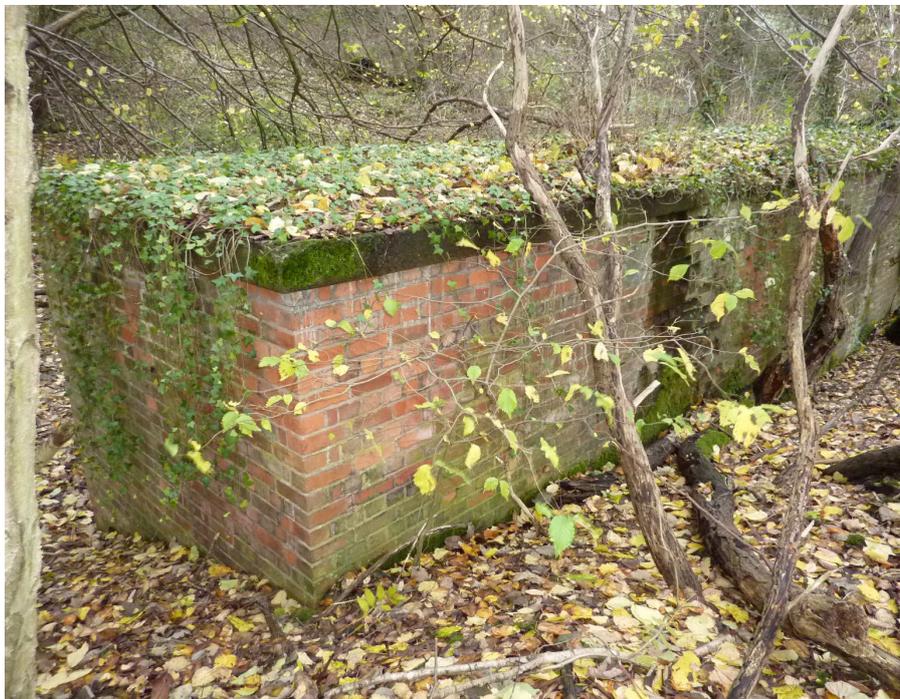
Fig. 016 Building 68 ARP Shelter, West Bank

The roof slab is covered in ivy and plant growth, but the exposed sections are in slightly better condition than building 67. There are some substantial trees growing in very close proximity to the building along the west elevation, consideration needs to be given to their removal before they cause significant displacement in the adjoining building fabric. There are spalled faces to the bricks evident particularly along the west elevation.

Internally the brick is very wet where the building is set into the hillside and to the underside of the roof slab. There is a depth of debris on the floor, which may conceal cracks to the slab beneath.

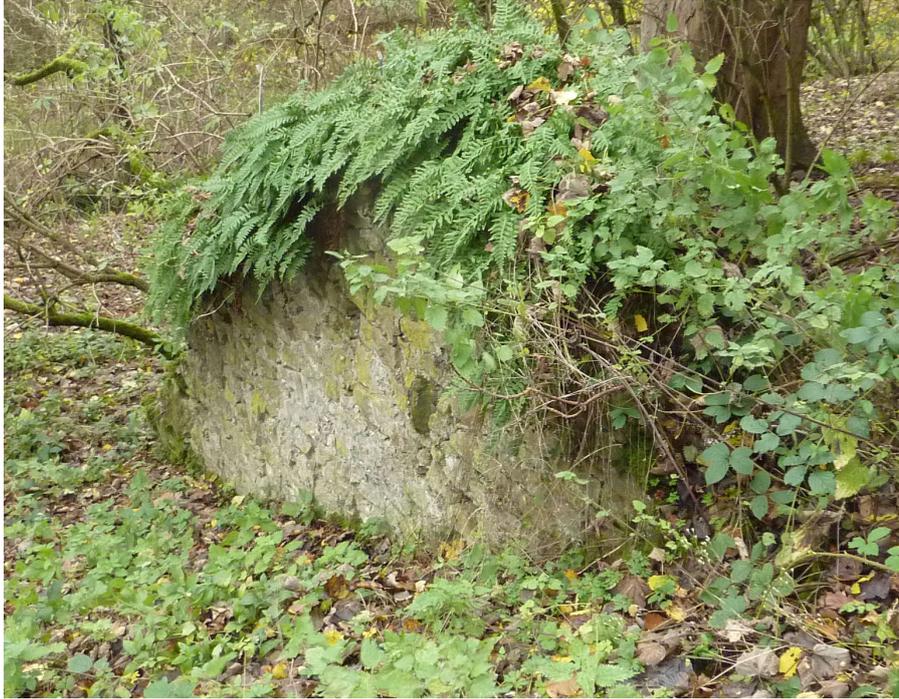
Fig. 018 Pre WWII Features Garden Wall

The boundary wall extends down the valley side, to the north of the garden. The wall remains intact outside the site, with a section missing where the path adjoins the palisade fence. A further fragmentary section remains in situ below the path. The Birmingham Archaeology report suggests that this formed the northern boundary of the foundry site.

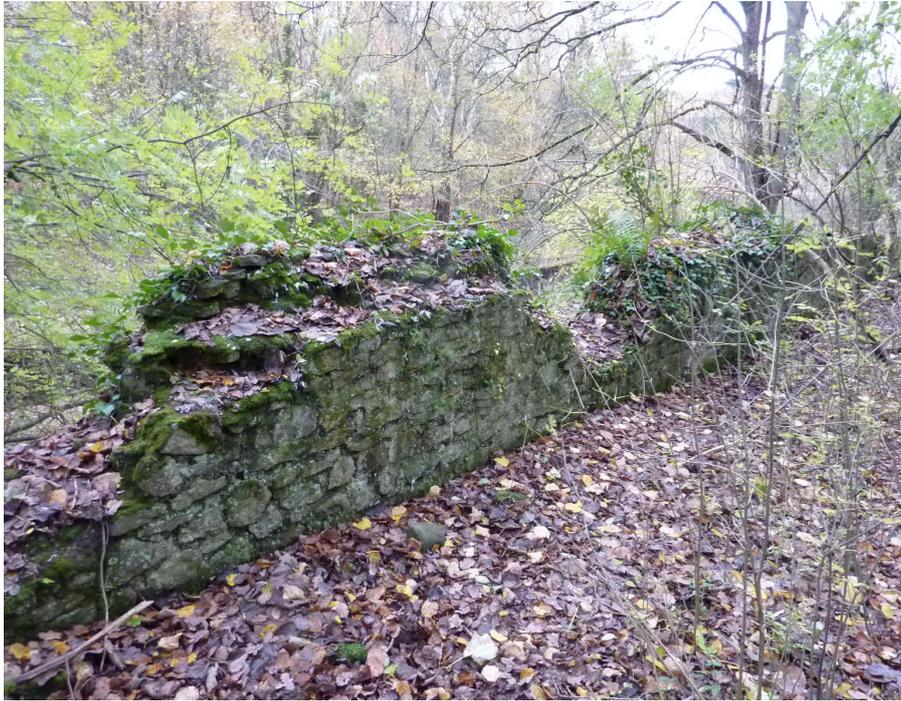
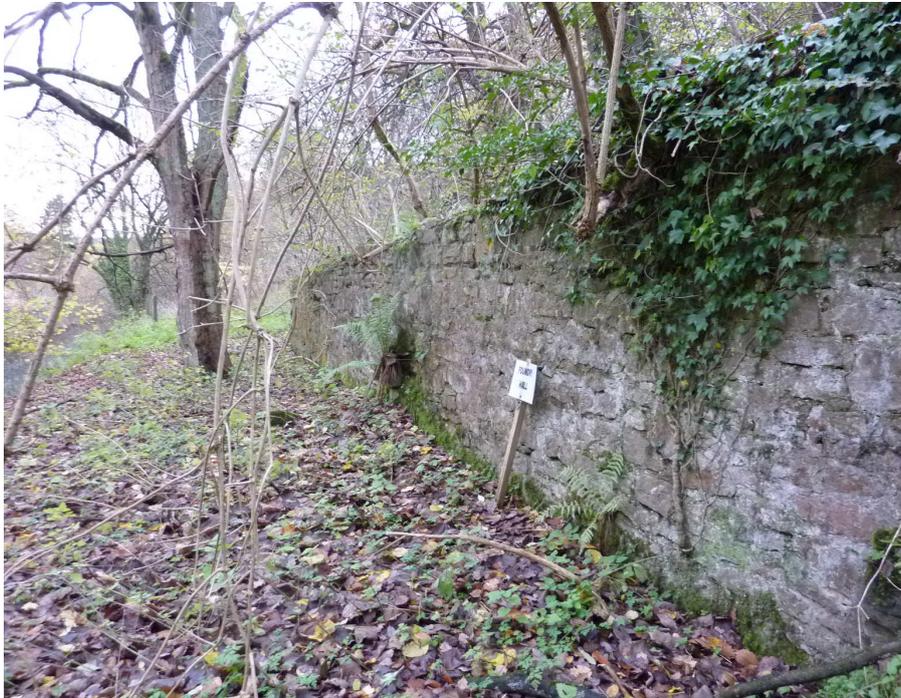
Fig. 020 Pre WWII Features Foundry Wall

The foundry wall dates from the second half of the 19<sup>th</sup> century, and would have formed the western elevation of the foundry building itself. This section of wall is probably the earliest remaining on the site. To the west the ground level is higher, and the wall serves as a part retaining wall for the banking above. To the east, the excavation of the culvert has resulted in additional build-up of material which will bolster the stability of the wall.

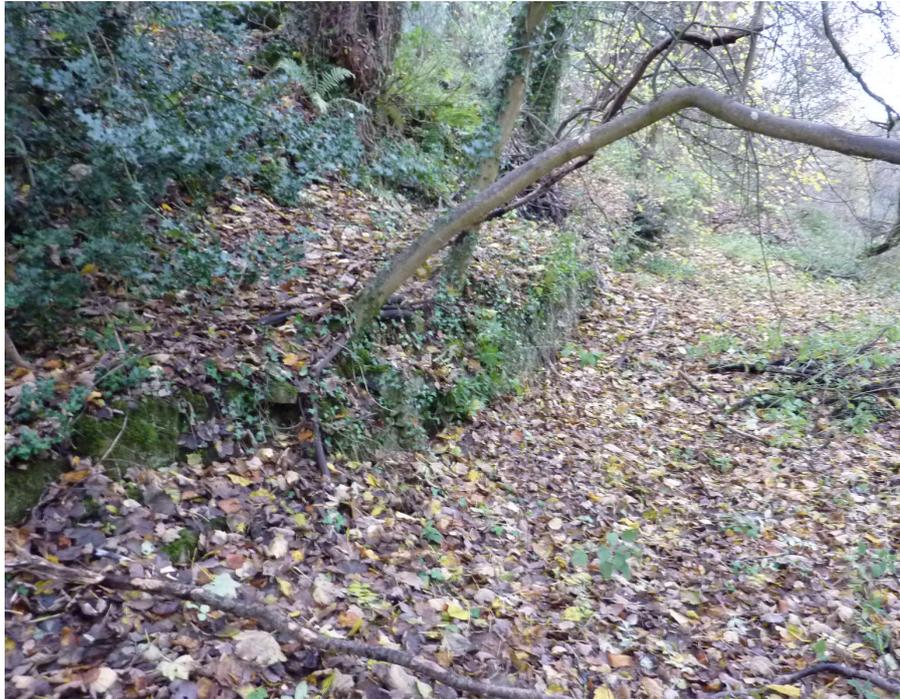
Fig. 022 Pre WWII Features Revetment Wall

To the north of the foundry wall is a revetment wall cut into the hillside. Above the wall are the remaining sections of trackway, much of which is outside the modern site boundary. The wall is of dry stone, built into the hillside, and remains up to 1m in height. Once again the spoil from the construction of the culvert is evident to the east, which may conceal more extensive structure.

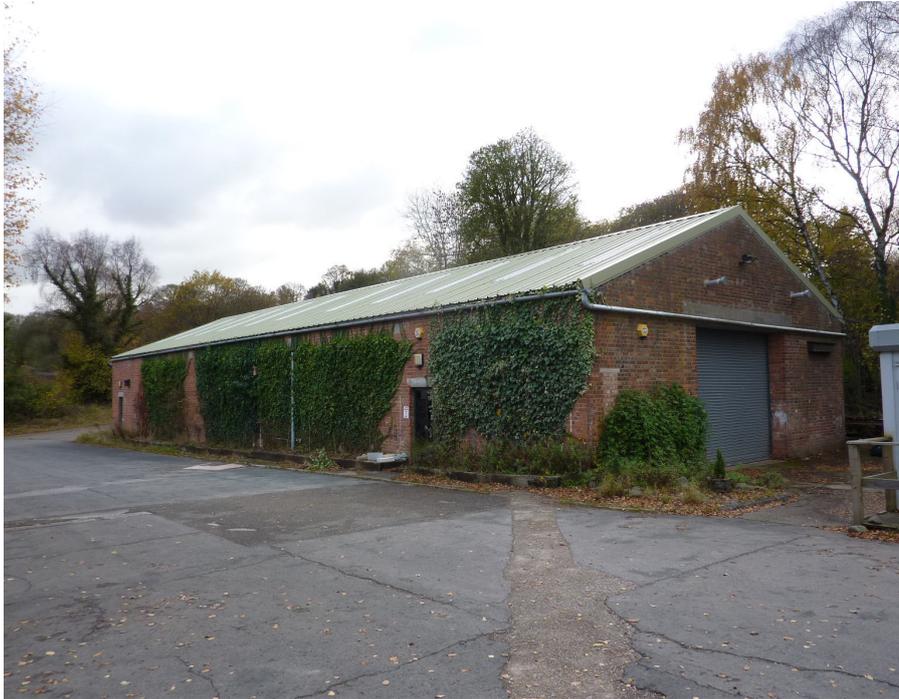
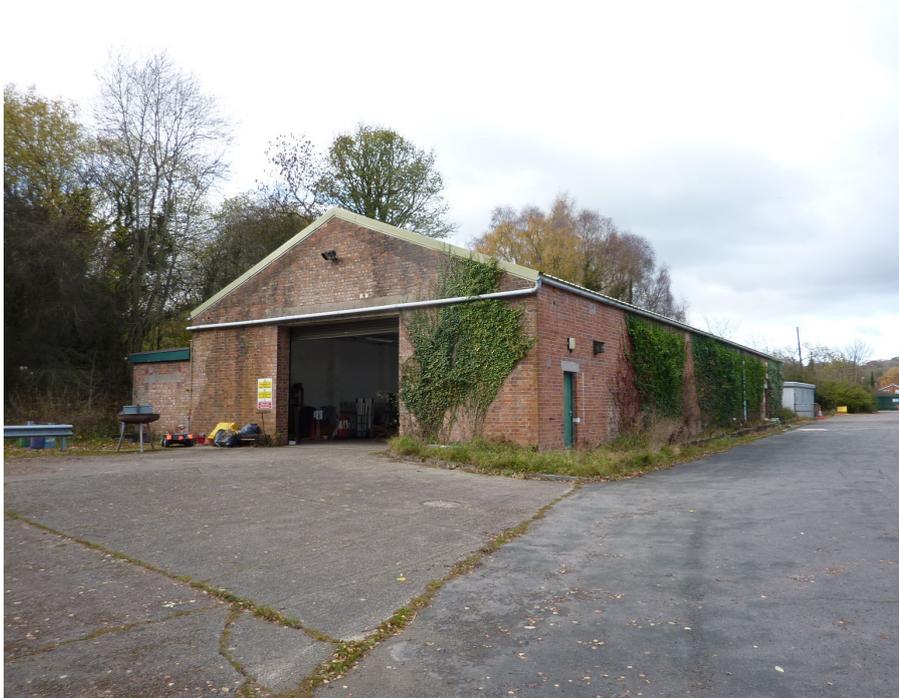
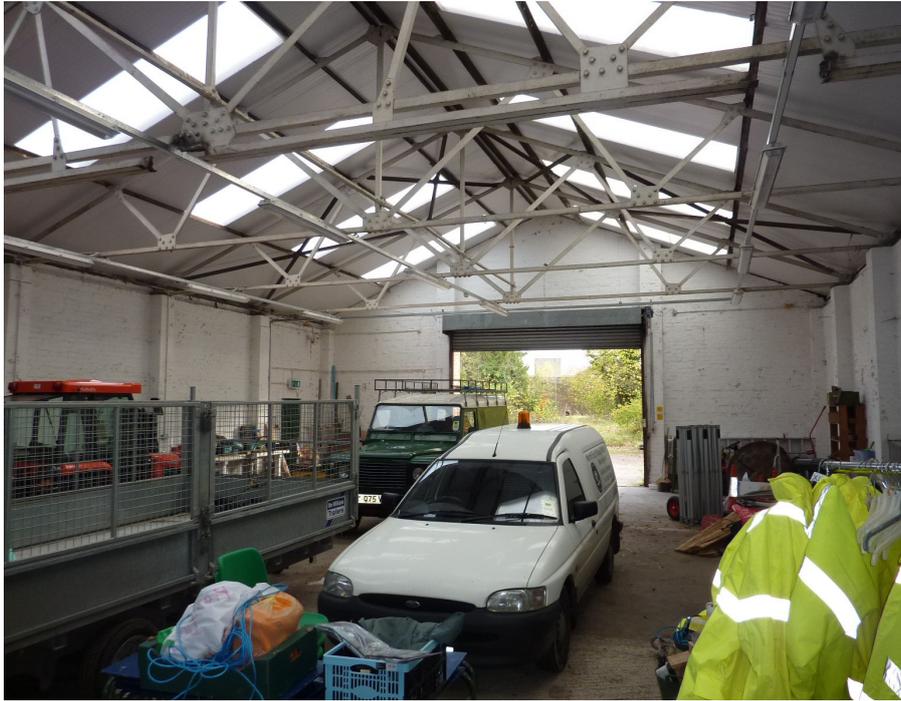
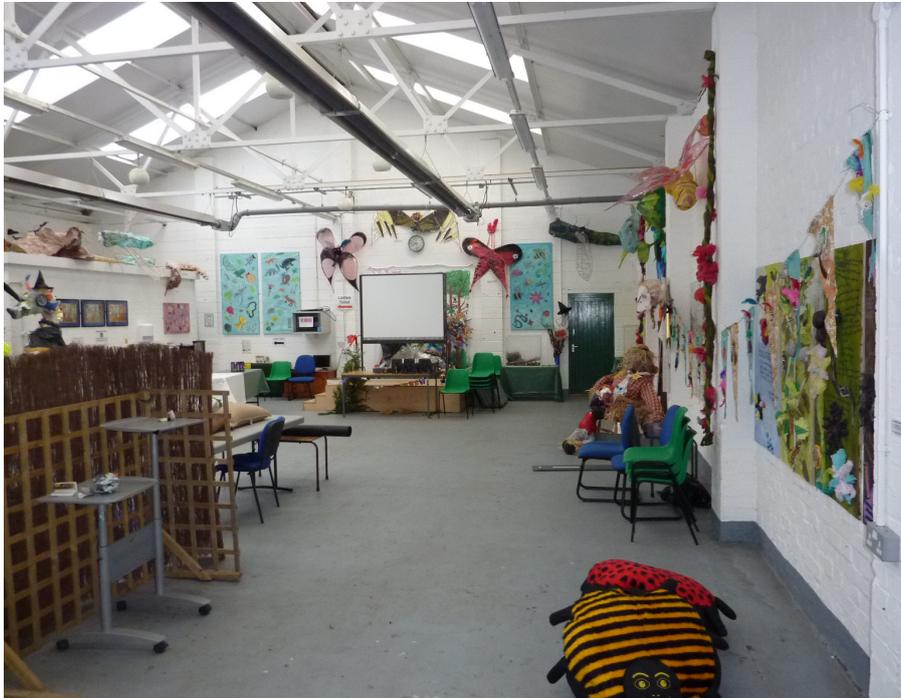
Fig. 025 Building 12 The Process Garage

The roof to the process garage has been renewed in a profiled metal sheet with a series of polycarbonate roof lights. At time of survey this was generally in good condition.

building, round to the rear, or west, elevation where they connect into gulleys at low level. The rain water goods are in good condition although there are climbing plants on the east elevation which require cutting back, and a section of gutter to the north-eastern corner requires realigning.

The north and south elevations both have large vehicular doors with galvanised roller shutters. Above the northern door there is a substantial concrete lintel, there is a vertical crack running down from the bearing of this lintel down through the wall. There is also some horizontal cracking above the lintel.

The brickwork to the north elevation is generally in good condition, with only a few spalled bricks. The brickwork to the east elevation is largely obscured by planted ivy growth, some of which extends up into the gutters and needs to be cut back to prevent blockage. The visible brickwork on this elevation is quite pitted and would appear to have been blast cleaned at some point in the past. Once again there are a number of spalled bricks but generally the brickwork is in reasonable condition. Visible at high level, projecting through the wall, are concrete padstones. These extend from the inside of the building where they cap the piers supporting the steel trusses. To each end of the east elevation are pedestrian doors with concrete lintels. At low level there is a planted bed hard up against the building in which are planted ivy and other plants. It is noted that the floor level in the education space is below the general floor level and with the additional build up of this raised bed it is likely to promote the retention of damp in the walls at low level, this should be monitored.

The south elevation mirrors the north with a large vehicular opening centrally. Once again this has a galvanised roller shutter with substantial concrete lintel over. There are cracks to the bearing points of this lintel and also a horizontal crack above. In general terms however the brickwork to this elevation is in reasonable condition. This elevation has a certain amount of its original camouflage paint remaining in-situ.

To the west elevation there is a small outrigger comprising a single storey with a reinforced concrete roof structure. This has had (probably timber) bearers added to form a fall to the west, with timber barge boards to each side draining into a half round UPVC gutter on the west elevation. A former doorway on the south has been infilled with modern brickwork. Once again the brickwork is in reasonable condition.

The garage consists of 6 bays, it is open to the underside of the steel roof decking with a lining sheet beneath. The roof structure and the sheeting is generally in reasonable condition. The walls are finished in a modern masonry paint, this is now peeling and flaking particularly to the east and west walls. The floor is a concrete slab of similar type to those found in other buildings elsewhere on the site. It is evident from the floor that there were originally three inspection pits to the northern end of the space which have been subsequently backfilled with concrete. The education room to the northern end of the building formed of five bays, once again the space is open to the roof structure. The trusses and bracing etc. are in a better decorative state given the public access to this space. Once again the walls are finished in a modern masonry paint, in this space this is generally in much better condition. There is a small brick building within the space with a reinforced concrete roof slab which has been modified for use as toilets associated with the education space. The floor in this space has been repaired and finished with a thermo plastic floor paint and is generally in good condition.
