# VALLEY SITE, RHYDYMWYN

# CONDITION REPORT

## Condition Report

Purcell Miller Tritton was commissioned by the Department for Environment Food and Rural Affairs (DEFRA), to undertake a condition survey and security survey on and for the former MS Valley Site, Rhydymwyn, Flintshire, North Wales. Survey work was undertaken during November and December 2010.

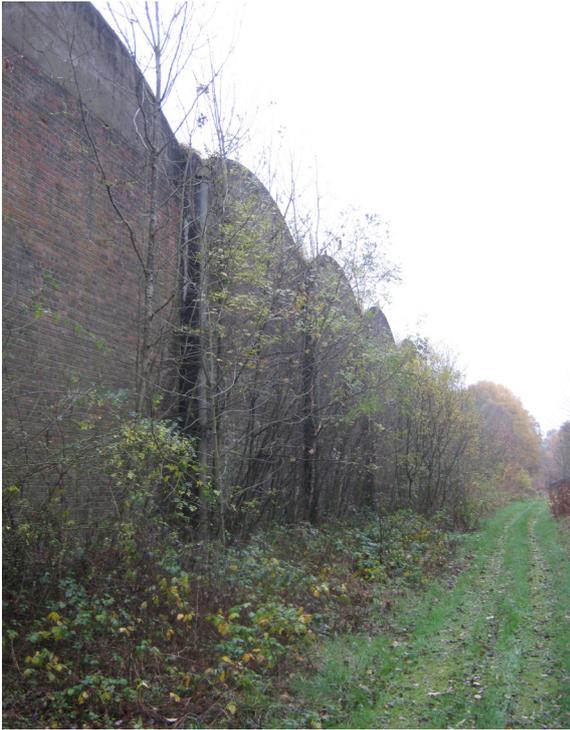
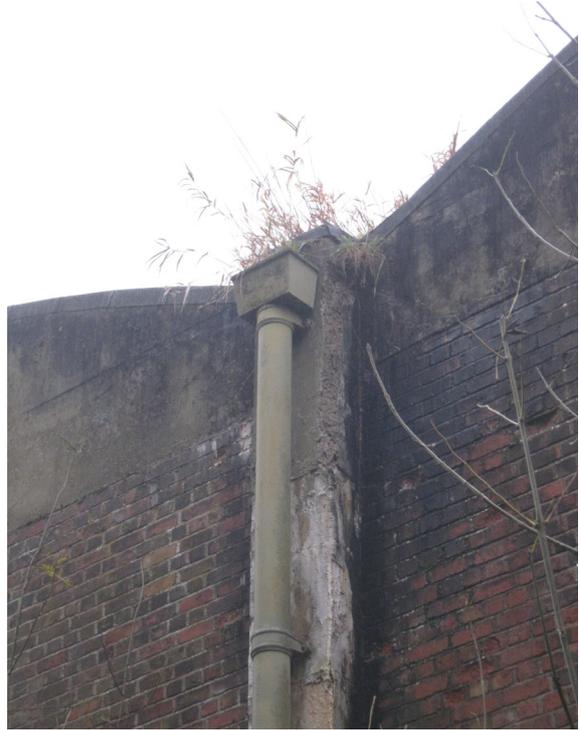
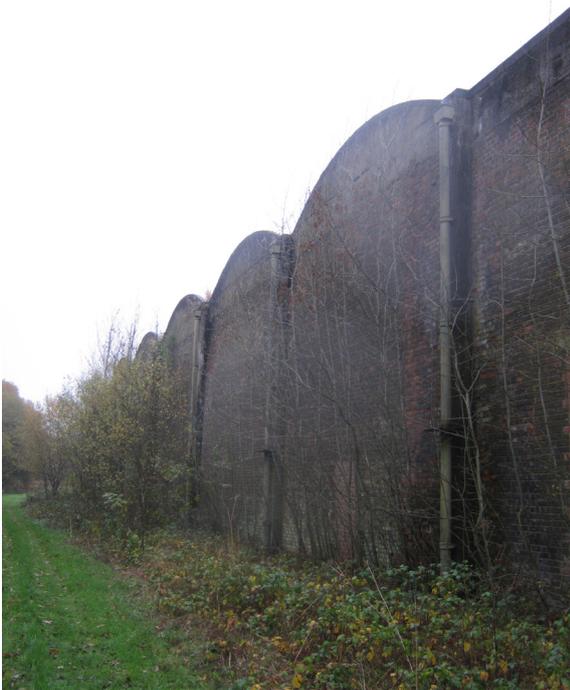
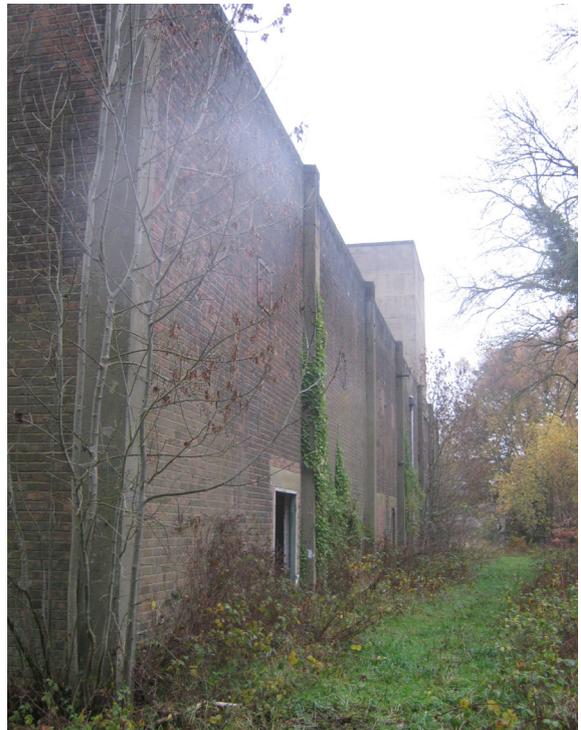
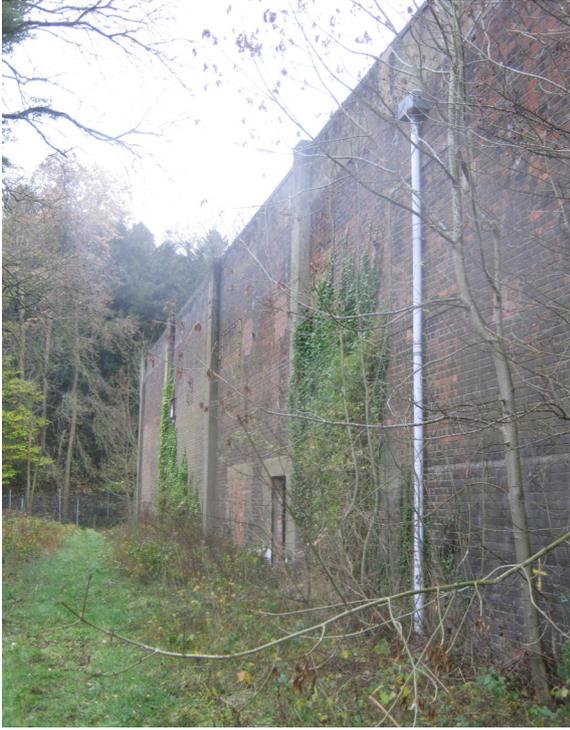
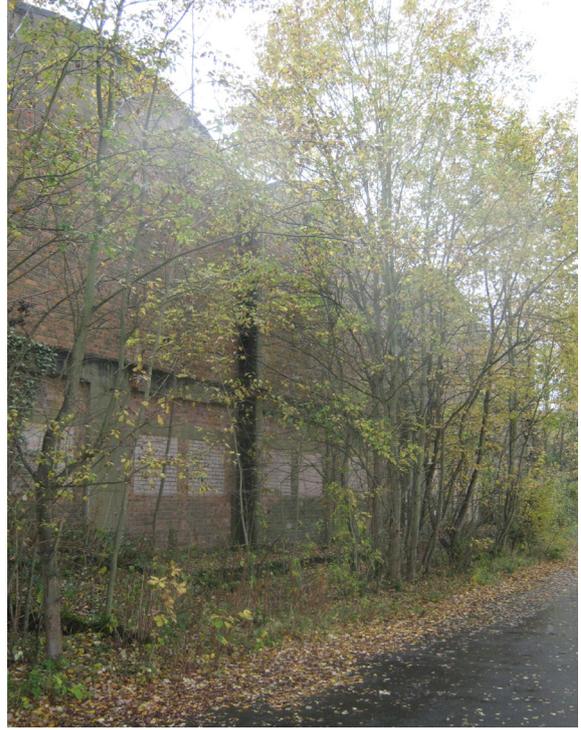
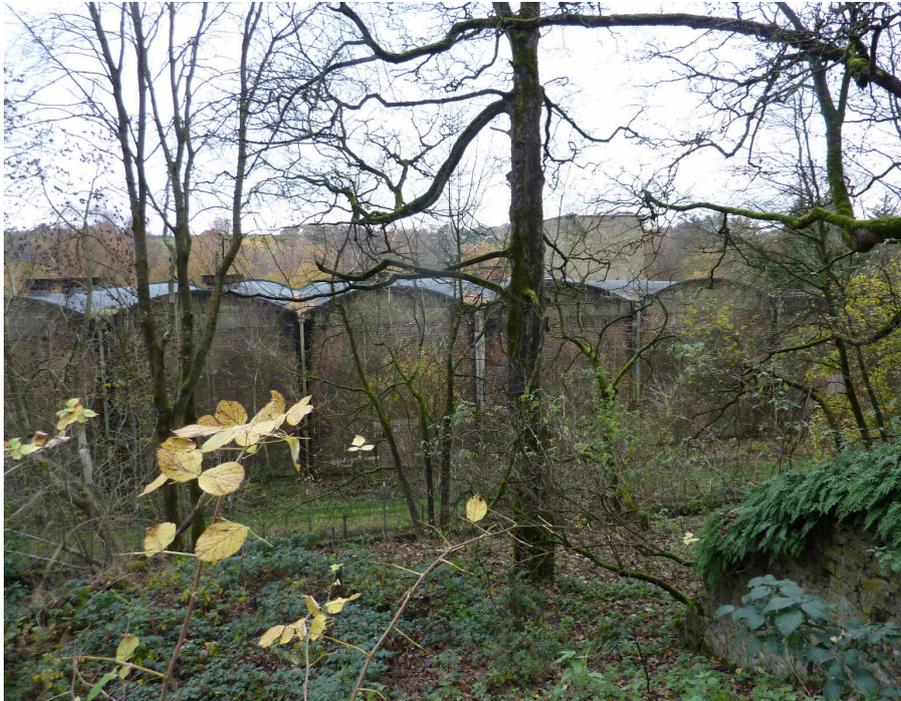
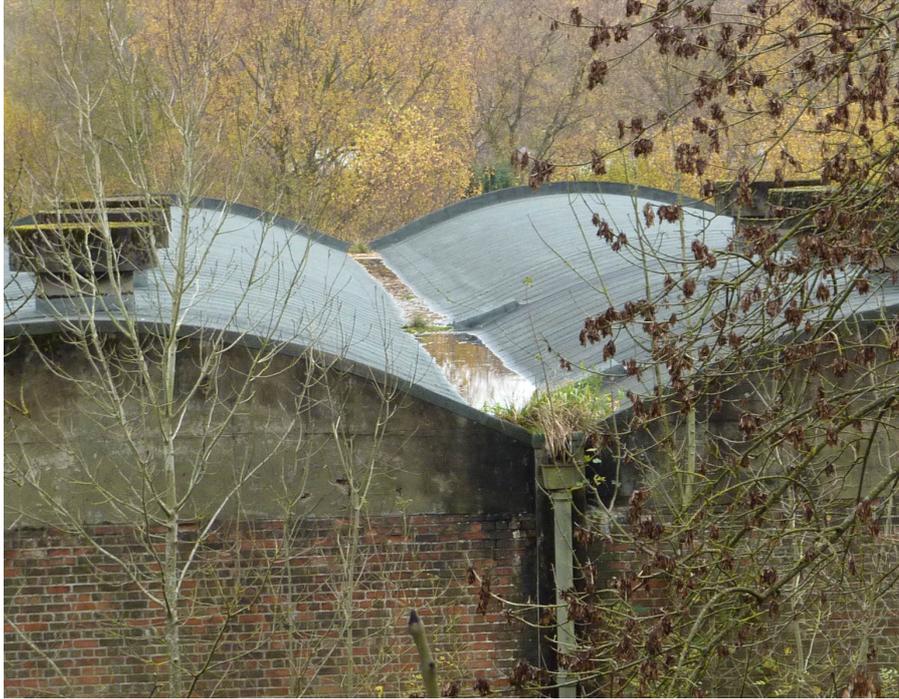
Fig.029 Building 45 The Tube Alloys Project (P6)

When viewed from the banking it is evident that the roofing felt is starting to deteriorate and losing its coating of solar chippings. This type of felt only has a life-span of 10-15 years so some failure is inevitable. This is further evidenced by the water ingress internally (refer to interior). It is also possible to see that the valley gutters between the arched vaults are backed up with water, caused by blocked gulleys and outlets. There is growth evident in most of these outlets (see below). It is recommended that a full inspection of the roof coverings be undertaken, however it is likely that full renewal of the roofing felt will be required in the near future.

Rainwater pipe 01 is in reasonable condition, with no significant signs of deterioration or freeze thaw cracking, however, the pier upon which it sits is saturated particularly at high level, suggesting that the outlet and the gulley are partially blocked, resulting in a section of spalled concrete immediately adjacent to the hopper.

Rainwater pipe 02 looks in reasonable order but, as with rainwater pipe 01, the wall around it is entirely saturated suggesting that the gulley and valley gutter are blocked. This is further evidenced by the visible organic growth growing over the parapet, from within the gulley area. These need cleaning as a matter of some urgency if they are not going to result in significant decay to the reinforced concrete structure.

Rainwater pipe 04 is also blocked, with growth evident in the valley gutter above. Here the problem has extended to cause significant deterioration in the reinforced concrete pier to such an extent that there is a build up of lime on the adjacent surface of the concrete. This pipe also has a section of galvanised steel repair at low level and would appear to have a freeze thaw crack some 2.5m off the ground (to the rear of the pipe) which is resulting in a further discharge of water onto the fabric to the building.

Rainwater pipe 05, once again the same issues with blocked hopper, blocked valley gutter and chute. There is visible growth in hopper and in the gutter beyond, saturated brickwork and concrete at high level. Once again the pipe has been repaired at low level using galvanised sheet. The leaks and overflowing water caused some decay in the reinforced concrete pier already and unless some action is taken as a matter of some urgency, this will only deteriorate.

Adjoining rainwater pipe 06 the pier is entirely saturated with further evidence that the hopper is blocked, however the rainwater pipe is in slightly better condition. All of the gulleys to the west elevation are obscured from view with extensive undergrowth and plant matter and it is likely that the below ground drainage is therefore blocked also. Given the proximity of the rainwater pipes to the River Alyn, it should be a simple matter to clear these and allow water to flow away.

Rainwater pipe 07 is in reasonable condition at high level, however, there is a large freeze thaw crack, about 700mm from the ground which has resulted in a section of the cast bracket breaking away completely. The gulley is entirely full of water, and appears to be blocked, overflowing onto the ground adjacent to the building.

To rainwater pipe 08 there is evidence of a blockage at high level as the reinforced concrete pier behind is very wet. There appears to be freeze thaw crack about half way down, as there is further saturation of the concrete behind. The pipe has been repaired at low level with a section of galvanised steel.

Rainwater pipe 09 is blocked at high level and the pier is entirely saturated. At low level there are trees growing out of the gulley immediately adjacent to the shoe of the rainwater pipe. Unless this is addressed urgently, there will start to be some significant deterioration in the reinforced concrete. Similar issues exist around rainwater pipe 10, however, there has started to be deterioration in the reinforced concrete pier at high level and adjacent to the lower of the horizontal reinforced concrete beams. It would appear that there is probably a crack somewhere into the rear of this pipe given the level of saturation at low level.

The upper most joint of rainwater pipe 11 is leaking with water cascading down the sides of the pipe, saturating the reinforced concrete pier, causing the presence of limes on the wall and the pier adjacent. At low level there is a substantial tree adjacent to the gulley which is evidently completely blocked.

Rainwater pipe 12 is in slightly better condition, however, there is evidence of leaks and the reinforced concrete pier is saturated, particularly at lower level. There is a tree growing out of the gully immediately adjacent to the shoe of the downpipe. To the east elevation a tree to the southernmost bay has caused the jacking of the corner of the drainage channel.

There is deterioration at high level to the pier on the north eastern corner with a section of cracked concrete adjacent to the parapet. Generally, however the piers on this elevation are distinctly better than those to be found on building 59.

The beams for the longitudinal cranes once again project through the brickwork on this elevation being supported on small sections of RSJ built into the wall. The easternmost of these has caused extensive cracking in the adjoining brickwork. This would appear to be primarily through distortion and movement rather than deterioration in the steelwork itself and there is a crack extending some 2' down from the bearing plate.

To the easternmost bay there is deterioration and delamination of brickwork faces, this extends across the facade but the eastern bay is definitely the worst. There are a series of openings which have been infilled with modern brickwork. The slam door emergency exits at high level have steel frames which remain in-situ, there is some corrosion to these frames which will eventually cause distress in the adjoining brickwork panels, but currently these are in reasonable condition. The louvre openings have been infilled with modern brickwork including large vehicular doors centrally. A modern door has been inserted to provide access through one of these openings.

The south elevation is also sub-divided into six bays with reinforced concrete columns projecting proud of the wall face to form piers and a horizontal beam at high level extending up to form the parapet. The westernmost pier has significant deterioration at parapet level with sections in imminent danger of falling.

The piers to this elevation are in worse condition, particularly at high level, than those on the north, the third pier from the east, in particular, has further spalling at high level.

The brickwork panels are in better condition, failing and delaminating bricks are limited to a handful particularly in the western most panel. There are some spalled sections to the base of the reinforced concrete beam at high level.

To the western-most bay there is a vehicular door which remains in-situ. It has an iron lining which has limited signs of corrosion and does not appear to be causing any distress in the adjoining brickwork, but it should be treated with a rust inhibitor or painted.

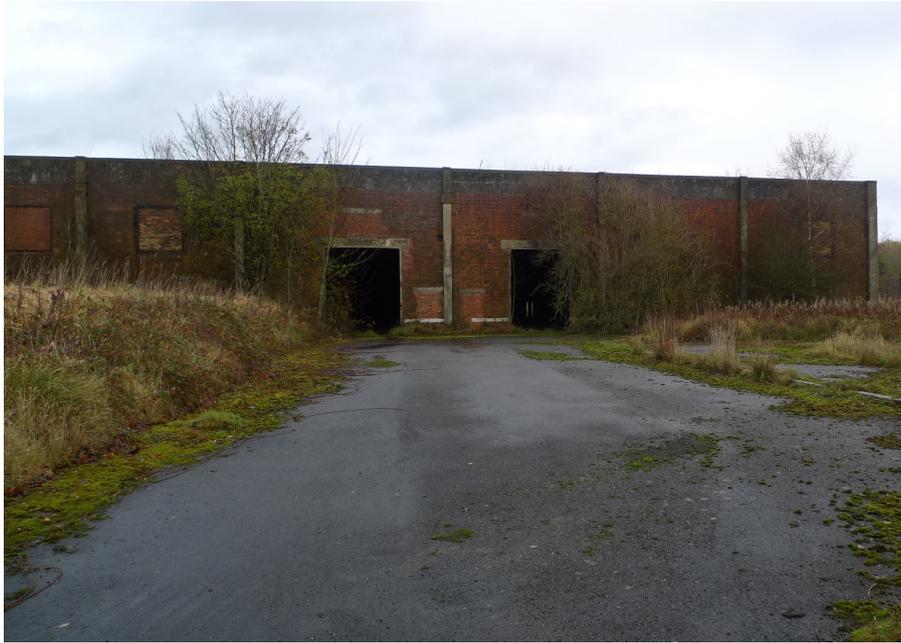
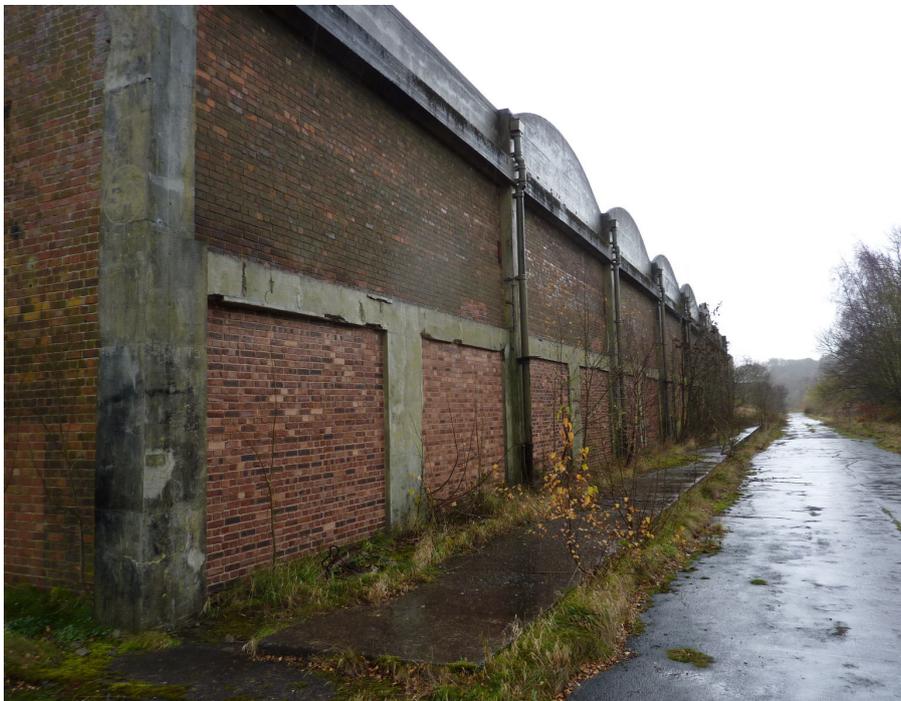
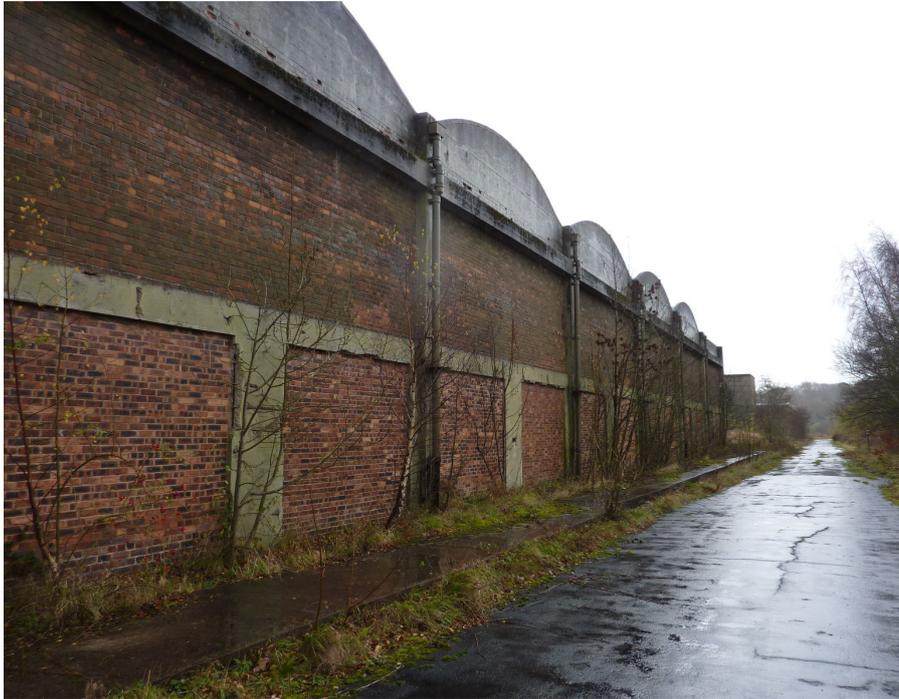
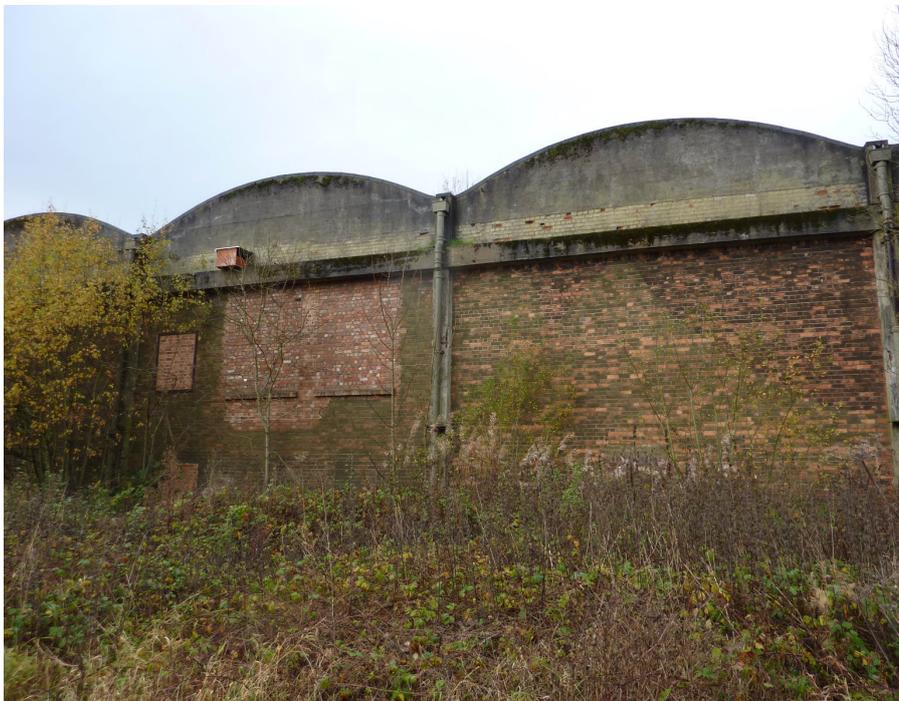
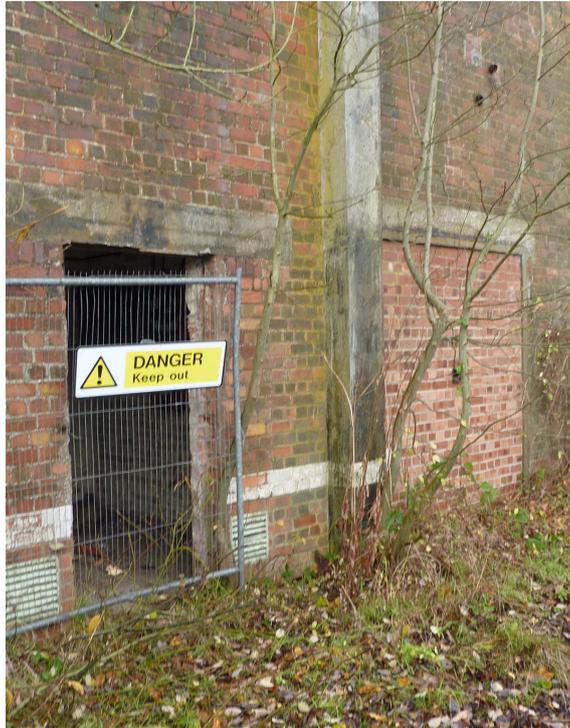
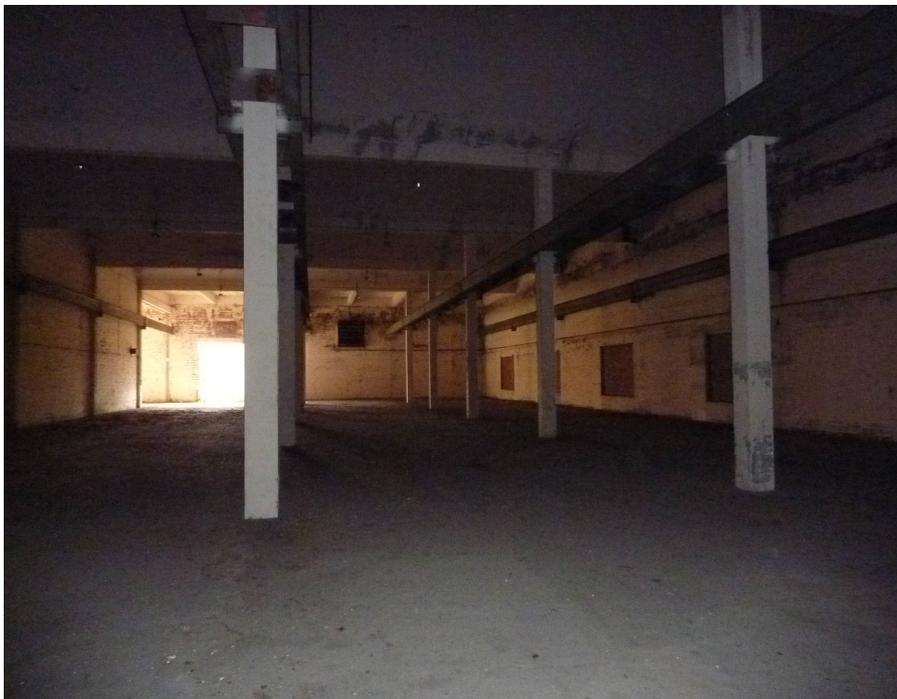
Fig. 037 Building 50 Former Pyro Building P5

Similar problems exist with the vertical columns between the original openings with sections of delaminating concrete exposing the reinforcement beneath. The whole of the reinforcement associated with these openings is in poor condition and will require some remedial and conservation work in the near future.

The brickwork panels above are generally in good condition with significant evidence of the original camouflage paint remaining in-situ. For notes on the condition of the projecting piers refer to rainwater goods. Either side of the projecting reinforced concrete piers is a tie and plate with two bolts, these are the fixing brackets supporting the internal horizontal gantry rails. Above the reinforced ring beam at high level there are approximately five courses of brickwork to the arched gables and then reinforced concrete above to the flat roof sections. The parapets are reinforced concrete. To the arched gables this brickwork is in quite poor condition in places with a number of spalled faces. Above, the reinforced concrete would appear to be in reasonable condition with only minor cracks and signs of deterioration.
