VALLEY SITE, RHYDYMWYN

SECURITY REPORT

Purcell Miller Tritton was commissioned by the Department for Environment Food and Rural Affairs (DEFRA), to undertake a condition survey and security survey on and for the former MS Valley Site, Rhydymwyn, Flintshire, North Wales. Survey work was undertaken during November and December 2010.

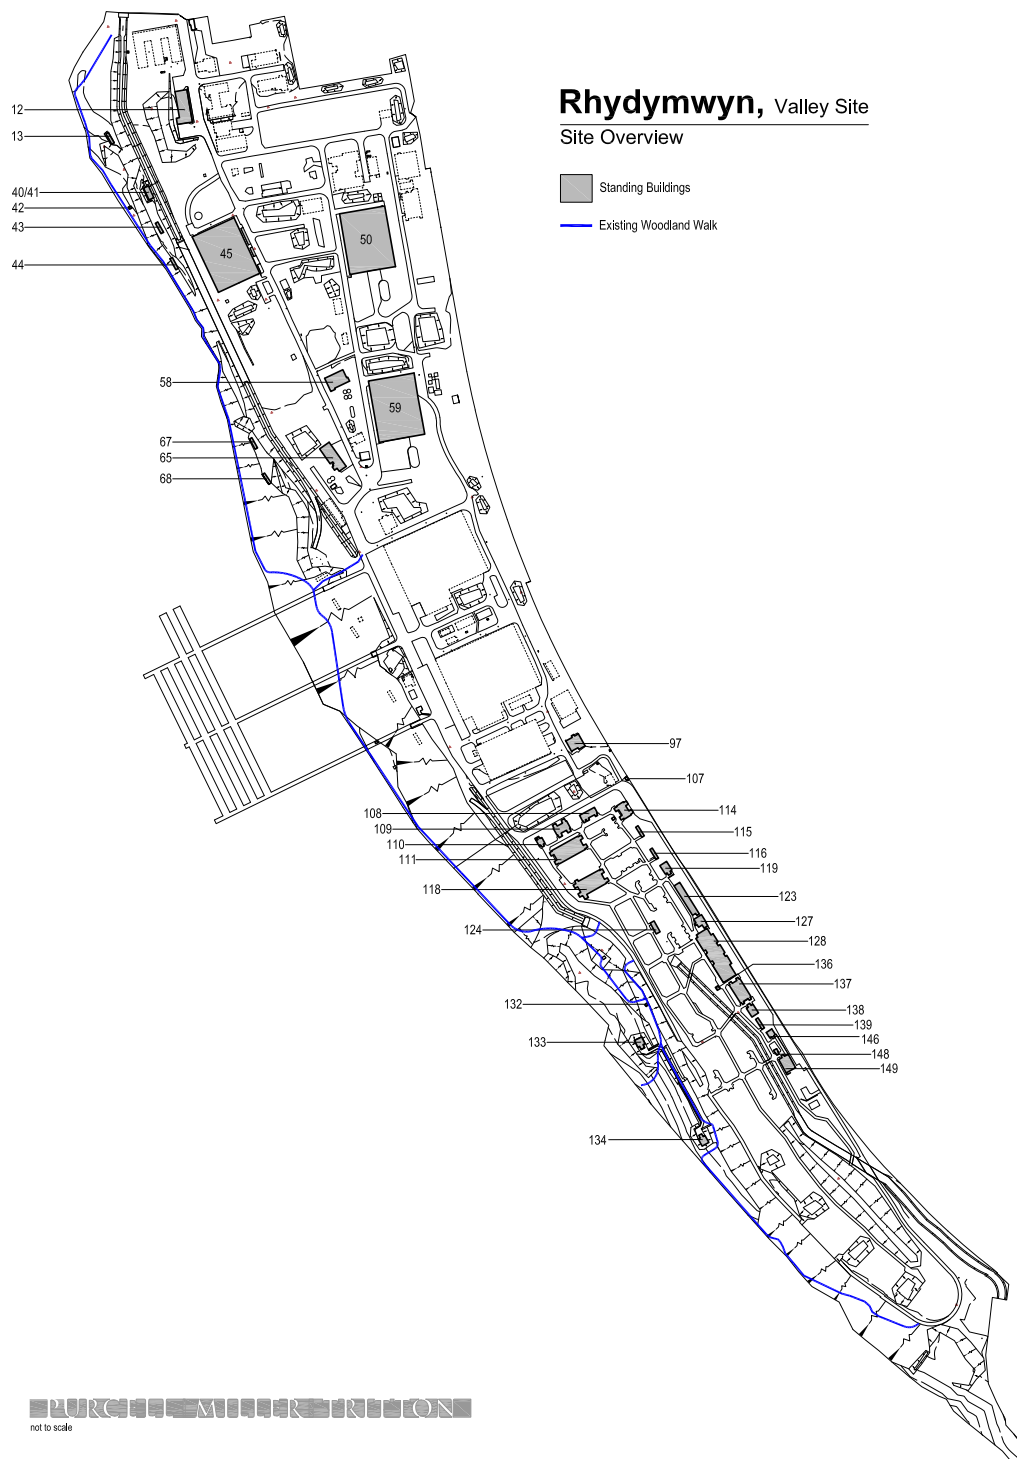
Fig. 1 - Woodland Walk

The Woodland Walk is a successful and, anecdotally, well appreciated part of the visitor experience at Rhydymwyn. There are inherent risks with climbing steep slopes and entering woodland that should be understood by Site Users. Sections of the Woodland Walk could be improved to reduce the risks posed to visitors. Where the path runs adjacent to the perimeter fence, the fence bracing obstructs the route. (See Fig. 1) The fence posts are rusty and pose an avoidable risk of injury to Site Users. As a minimum the fence posts should be maintained and repaired but consideration should be given to widening the path or rerouting the Woodland Walk to avoid the fence bracing. A section of the Woodland Walk bisects the access route between the Gunpowder Magazine Rooms - Buildings 133 & 134. Before access to Building 134 is encouraged the clash of pathways requires resolution.
