VALLEY SITE, RHYDYMWYN

SECURITY REPORT

Purcell Miller Tritton was commissioned by the Department for Environment Food and Rural Affairs (DEFRA), to undertake a condition survey and security survey on and for the former MS Valley Site, Rhydymwyn, Flintshire, North Wales. Survey work was undertaken during November and December 2010.

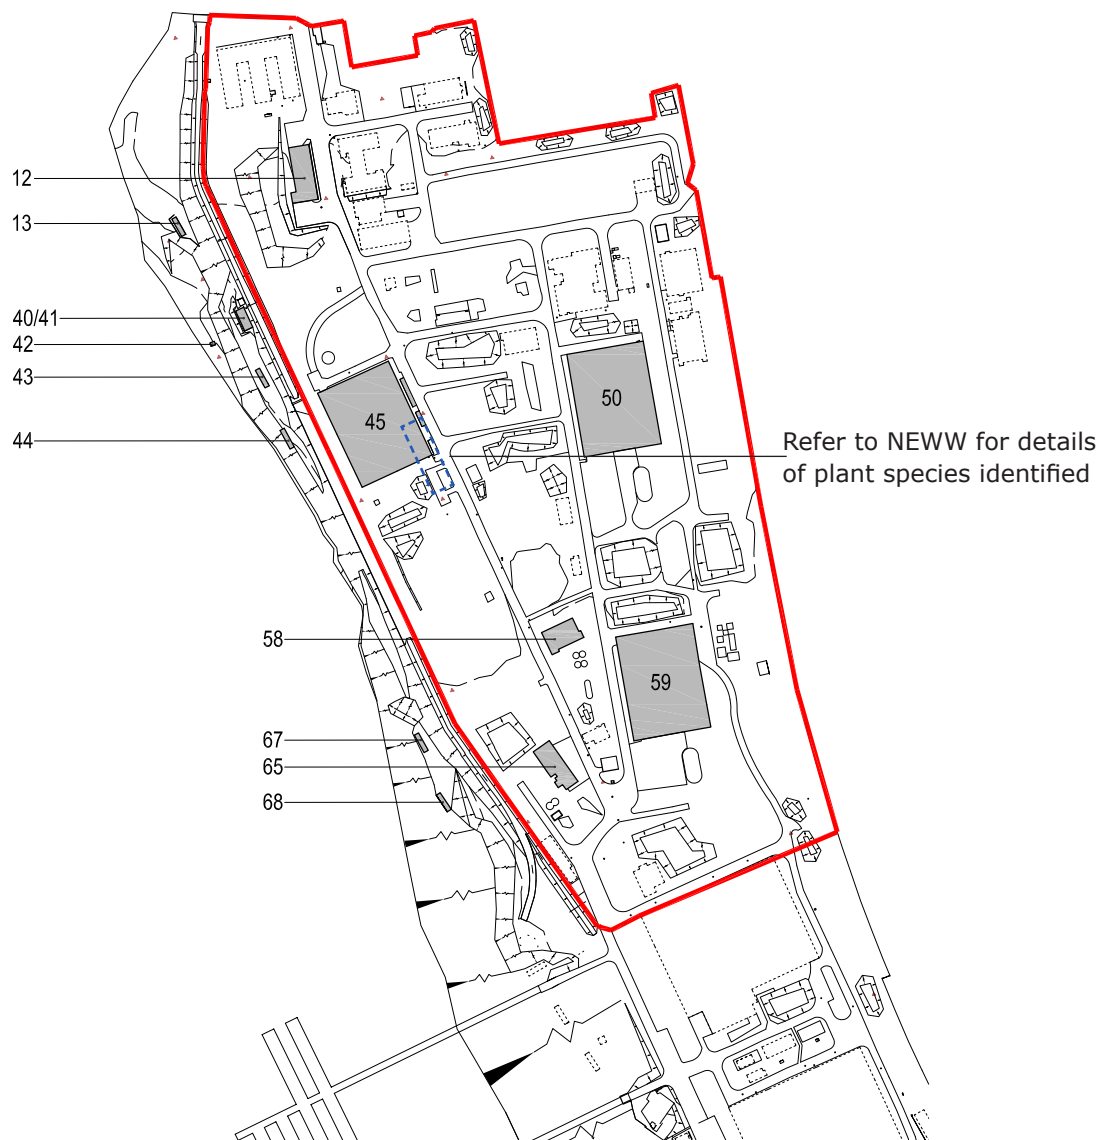
Fig. 4 - NEWW Site of Special Interest

The undergrowth between the plinth and the roadway adjacent to the southern bay is currently home to Lesser Bird's Nest, a rare plant. See fig. 4 This is not an exclusive incidence of the presence of a rare plant at Rhydymwyn but was drawn to our attention by NEWW when carrying out the survey. Due care should be taken to consulting NEWW on the proposed methodology for carrying
